Contract #: 04-0120F4Cty: SF/ALA Rte: 80 PM: 13.2/13.9File #: 69.28**WELDING INSPECTION REPORT****Resident Engineer:**Siegenthaler, Peter**Address:** 333 Burma Road**City:** Oakland, CA 94607**Report No:** WIR-021532**Date Inspected:** 07-Mar-2011**Project Name:** SAS Superstructure**OSM Arrival Time:** 700**Prime Contractor:** American Bridge/Fluor Enterprises, a JV**OSM Departure Time:** 1900**Contractor:** Zhenhua Port Machinery Company, Ltd (ZPMC), Changxing Island **Location:** Shanghai,China**CWI Name:** Lv Li Qing /Geng Wei**CWI Present:** Yes No**Inspected CWI report:** Yes No N/A**Rod Oven in Use:** Yes No N/A**Electrode to specification:** Yes No N/A**Weld Procedures Followed:** Yes No N/A**Qualified Welders:** Yes No N/A**Verified Joint Fit-up:** Yes No N/A**Approved Drawings:** Yes No N/A**Approved WPS:** Yes No N/A**Delayed / Cancelled:** Yes No N/A**Bridge No:** 34-0006**Component:** OBG**Summary of Items Observed:**

WELDING INSPECTION REPORT

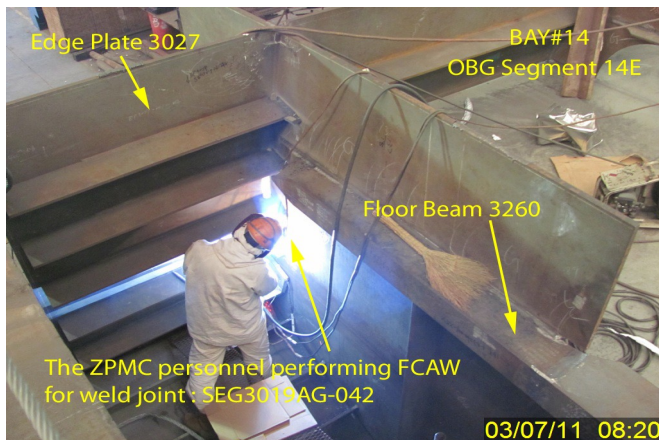
FCAW in the 1G position for the OBG Segment 14E Edge plate stiffener to Floor Beam. The weld joint was designated as: SEG3019AG-042. The welder is identified as #066733. ZPMC QC is identified as Mr. Zhong Guo

Hui. The welding variables recorded by QC appear to comply with WPS-B-T-2231-ESAB. Please see the attached picture.

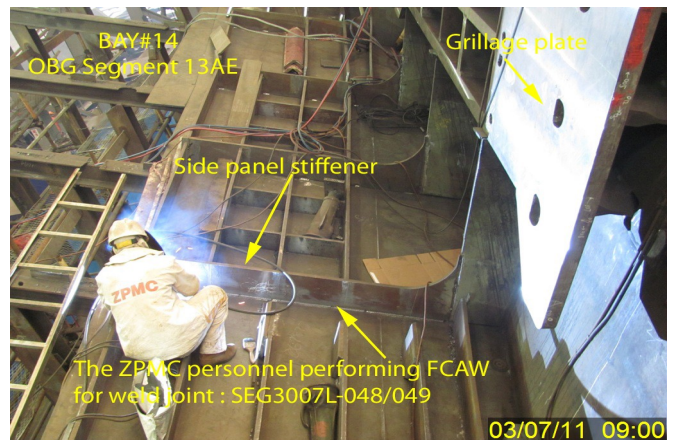
FCAW in the 3F position for the OBG Segment 13AE Side plate stiffener. The weld joint was designated as: SEG3007L-048/049. The welder is identified as #067877. ZPMC CWI is identified as Mr. Liu Hui Jie. The welding variables recorded by QC appear to comply with WPS-B-T-2133-ESAB. Please see the attached picture.
